# The Esso Longford Gas Plant Accident

## Report of the Longford Royal Commission

## **The Esso Longford Gas Plant Accident Report of the Longford Royal Commission**

**JUNE 1999**

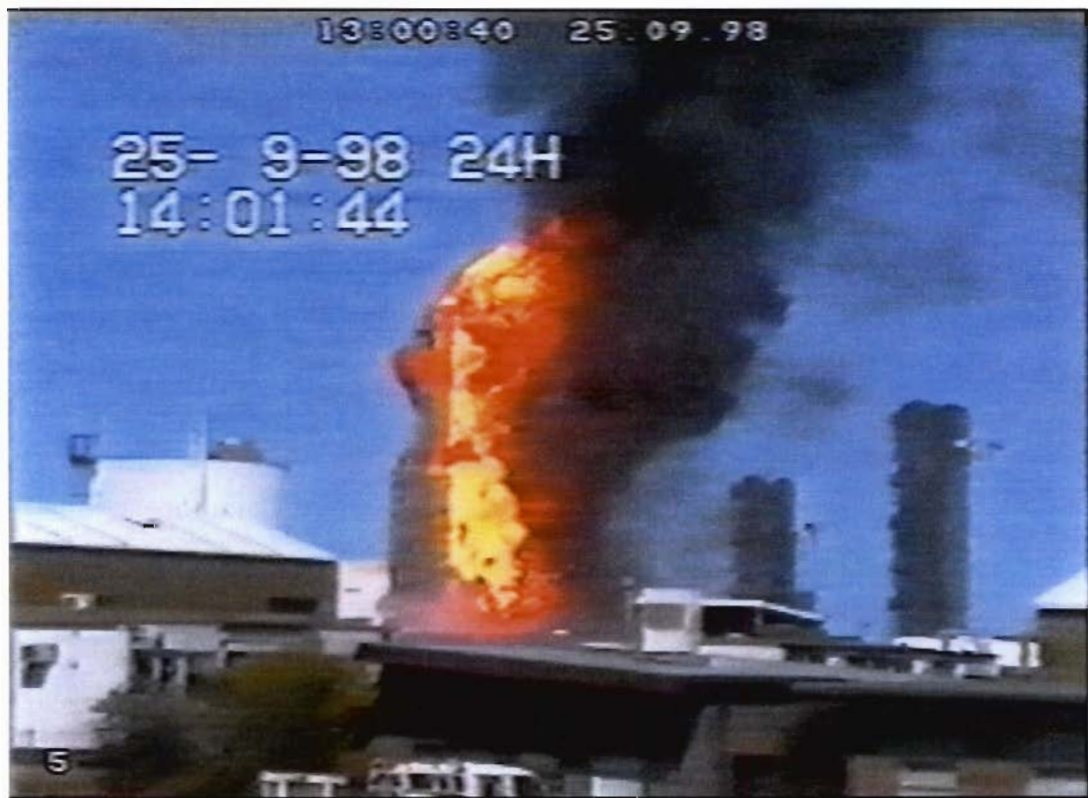
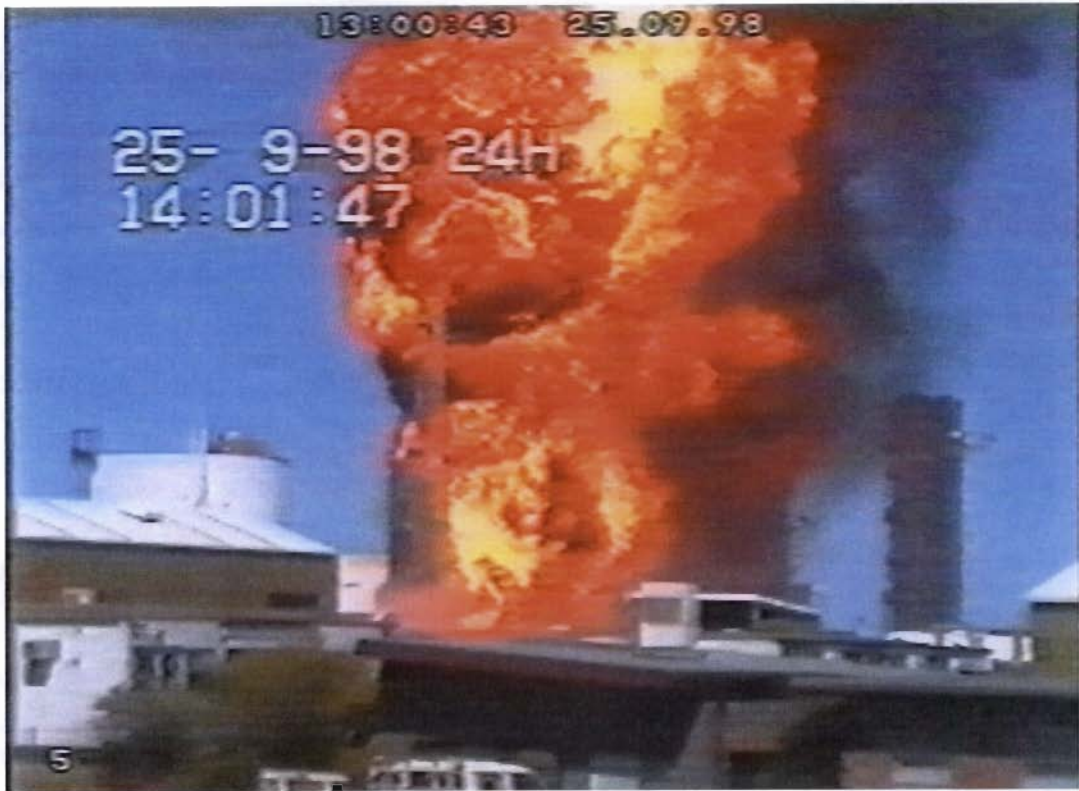
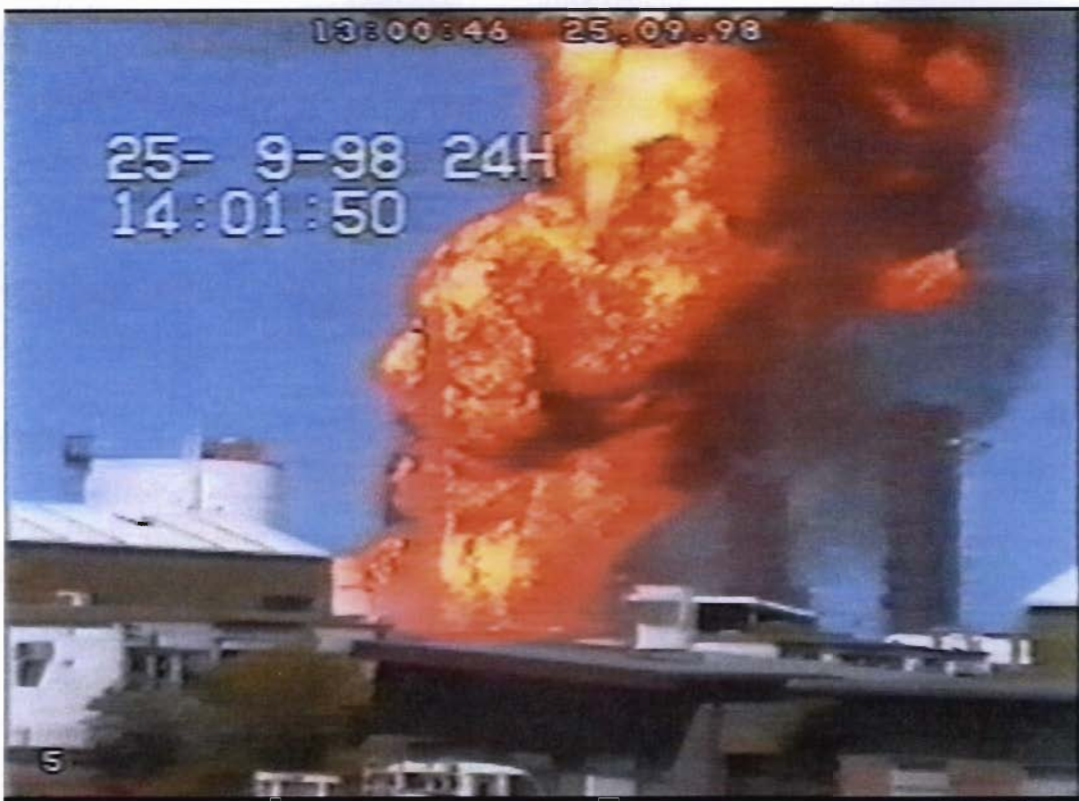
7.19 At 1.00 pm, only minutes before their arrival, the security video cameras recorded a major explosion from the site of the fires. A ball of flames approximately 40m in width and at least 70m high erupted from ROD/ROF area. This explosion was a consequence of the rupture of one of the large pipes in the east/west piperack in the King's Cross area and the subsequent release of its contents to the atmosphere in the immediate vicinity of the seat of the fire.

- 8.42 The first of the major pipe ruptures in the east/west piperack occurred at about 1.00 pm and resulted in the explosion recorded by the security video camera (see Figure 7.2 to Figure 7.4).

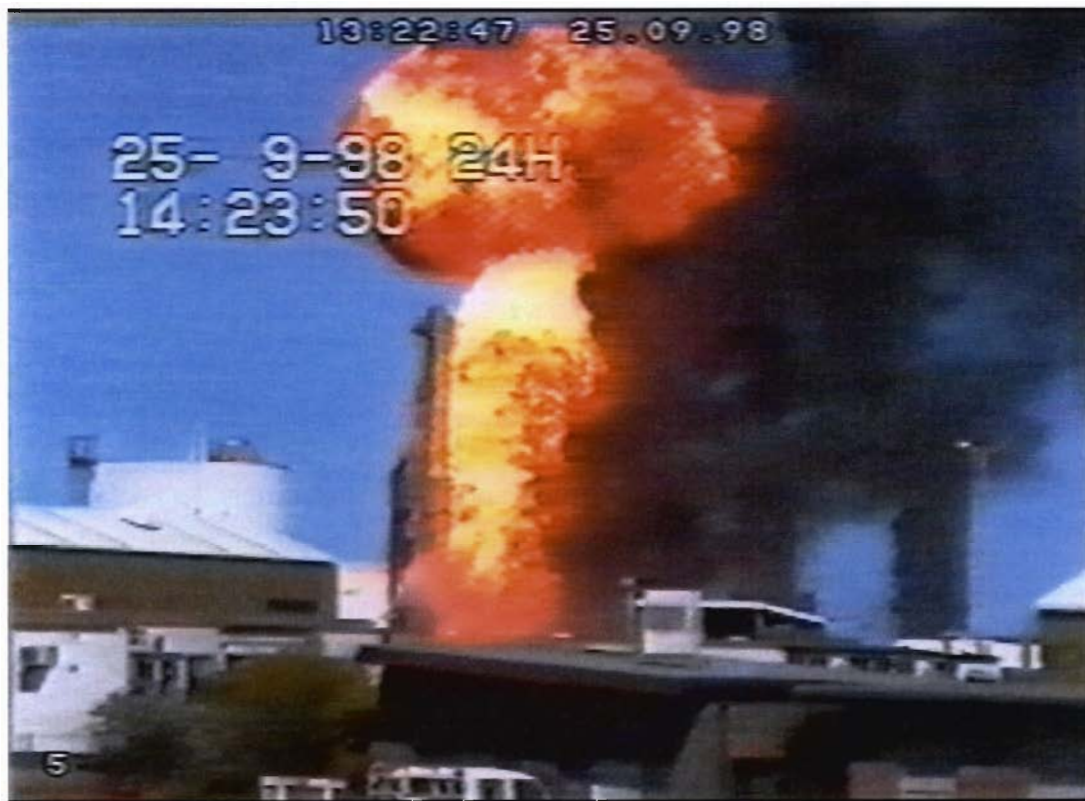
*Figure 7.5 The second major release, at 13:22:47*

7.29 After gaining entry, the Sale pumper was the first fire brigade appliance to reach the fire. It took up position in the vicinity of the GPI control room. At about 1.26 pm, while the Sale Brigade fire crew were positioning hose lines, there was a further explosion at the seat of the fire which dramatically increased its size and intensity. One witness described it as an explosion at the base of the fire and a large fireball erupting into the air. The security cameras recorded this explosion and fireball at 13:22:47.

- 8.43 Further explosions occurred at about 1.26 pm and 1.35 pm. These explosions, also clearly recorded by the security video camera (Figure 7.5 and Figure 7.6 to Figure 7.10 respectively), were the consequence of continuing ruptures of pipes in the east/west piperack. The failure of these pipes provided further sources of fuel mainly from the CSP.

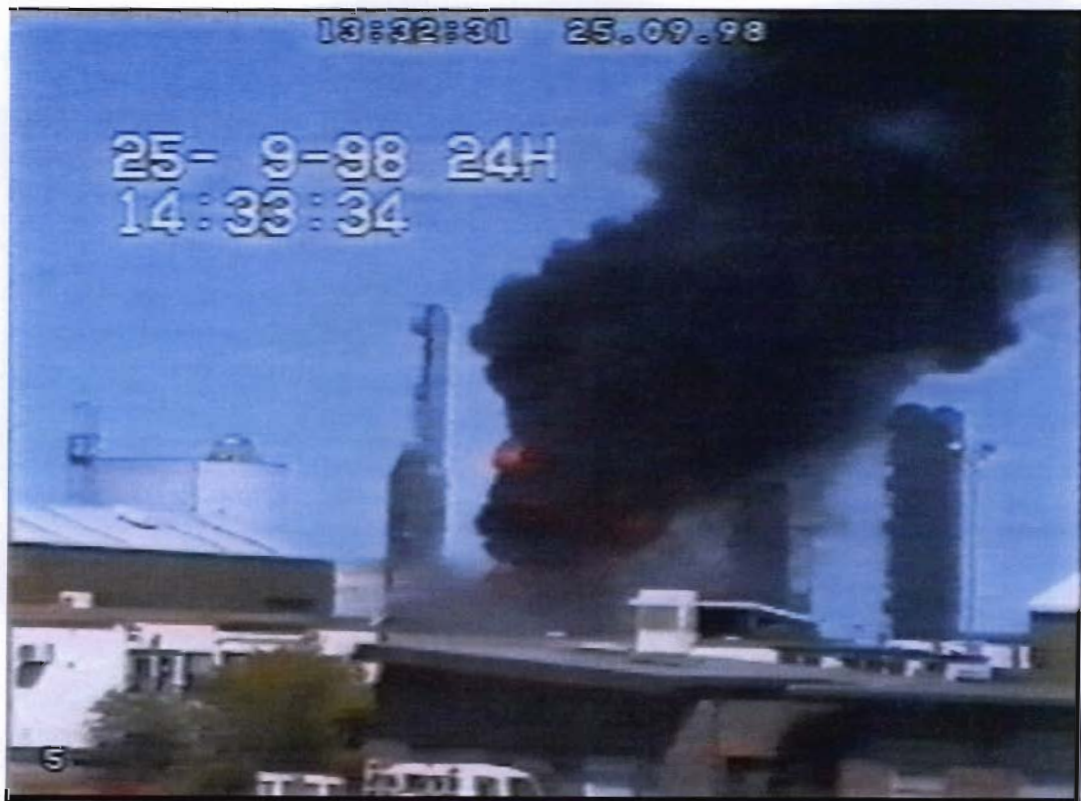
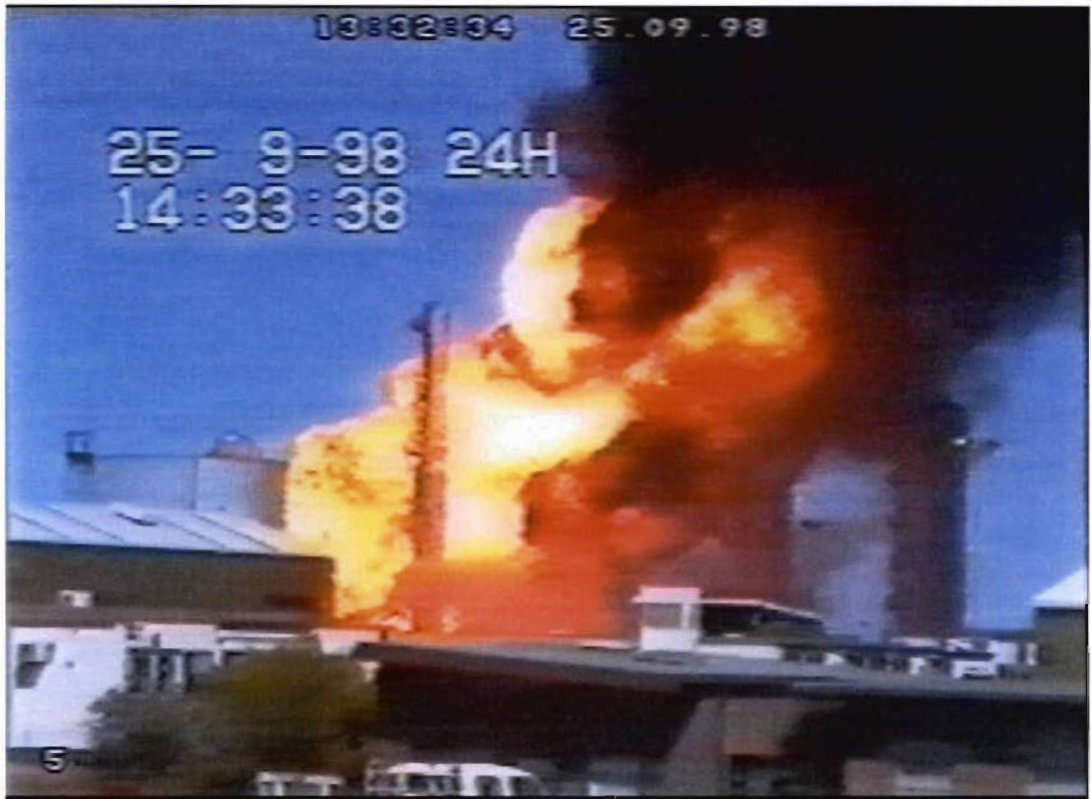
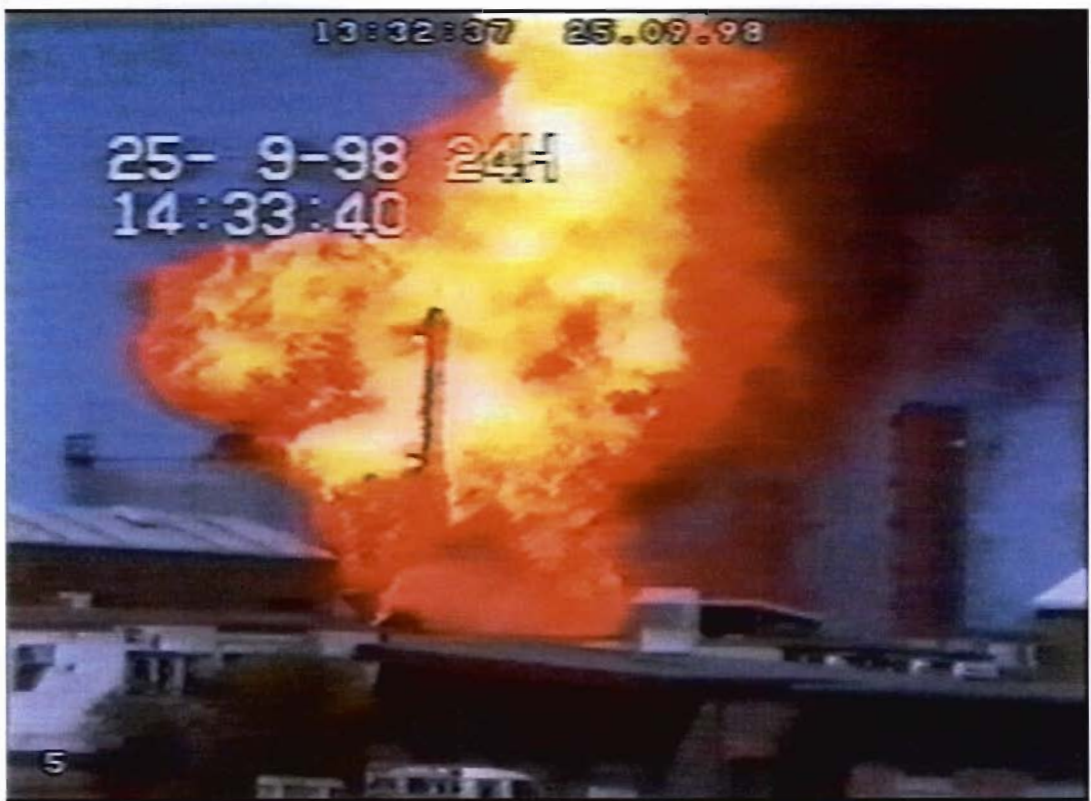
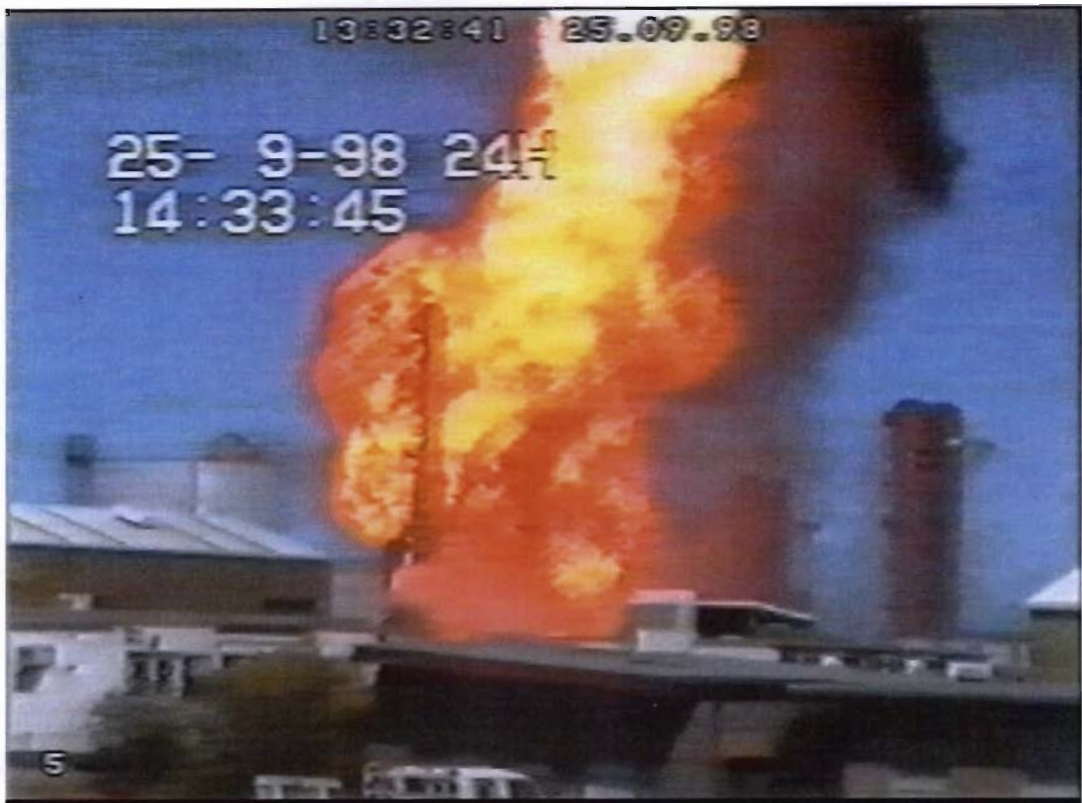
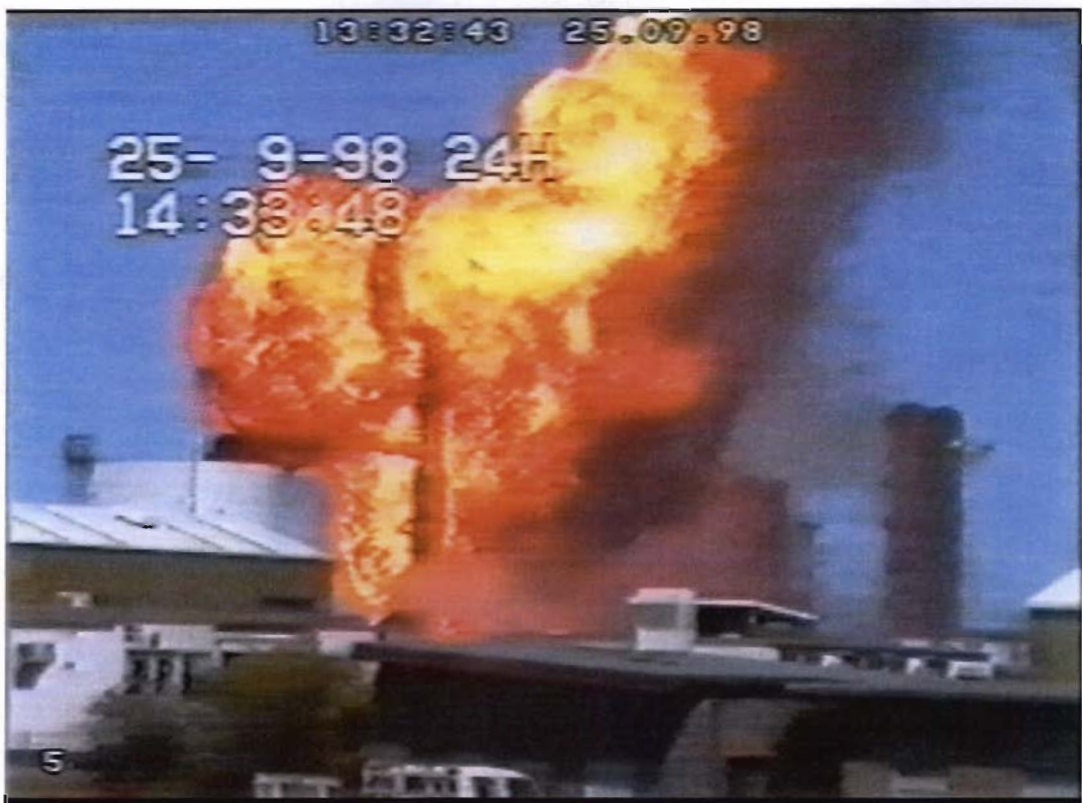
7.32 At about 1.35 pm the final and largest explosion occurred. The explosion was preceded by an evident reduction in the noise level of escaping gas. At the time it occurred, Quine and Brack were at the eastern end of the GP1 combinaire. The force of the blast was sufficient to knock them off balance. The blast was accompanied by intense heat. Quine and Brack observed a large fireball rise into the air and saw the metal ladder on the ROD tower melt rapidly.

7.33 The security cameras recorded this blast as occurring at 13:32 hours. As can be seen from the pictures, the flame heights were in excess of 100 meters high and 55 meters wide.

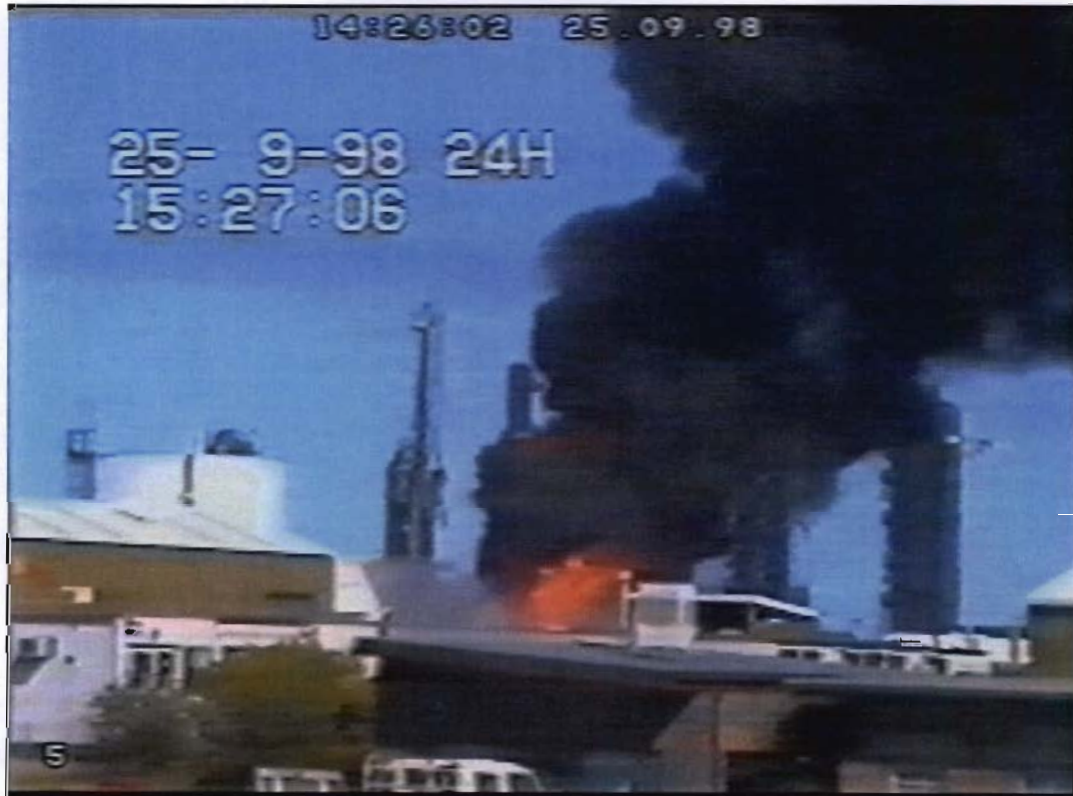
*Figure 7.11 The fire at 14:26:02*

7.40 By 2.25pm the flames in the vicinity of the GP905 exchanger had diminished. The fire as recorded on the security video camera (at approximately 2.26 pm) consisted of a red-orange flame approximately 10-15m in height and a large plume of thick black smoke.

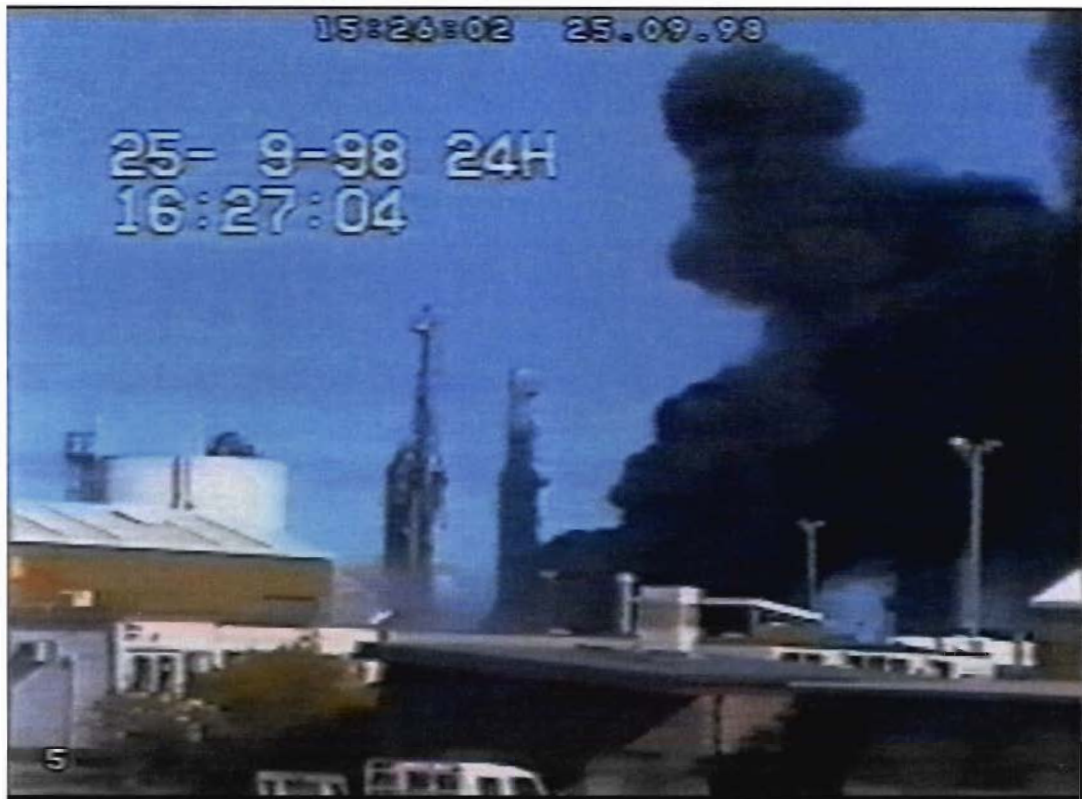
*Figure 7.12 The fire at 15:26:02*

- 7.43 By this time the flames in the fire area had died down to below 10 metres in height accompanied by a large billowing cloud of black smoke.

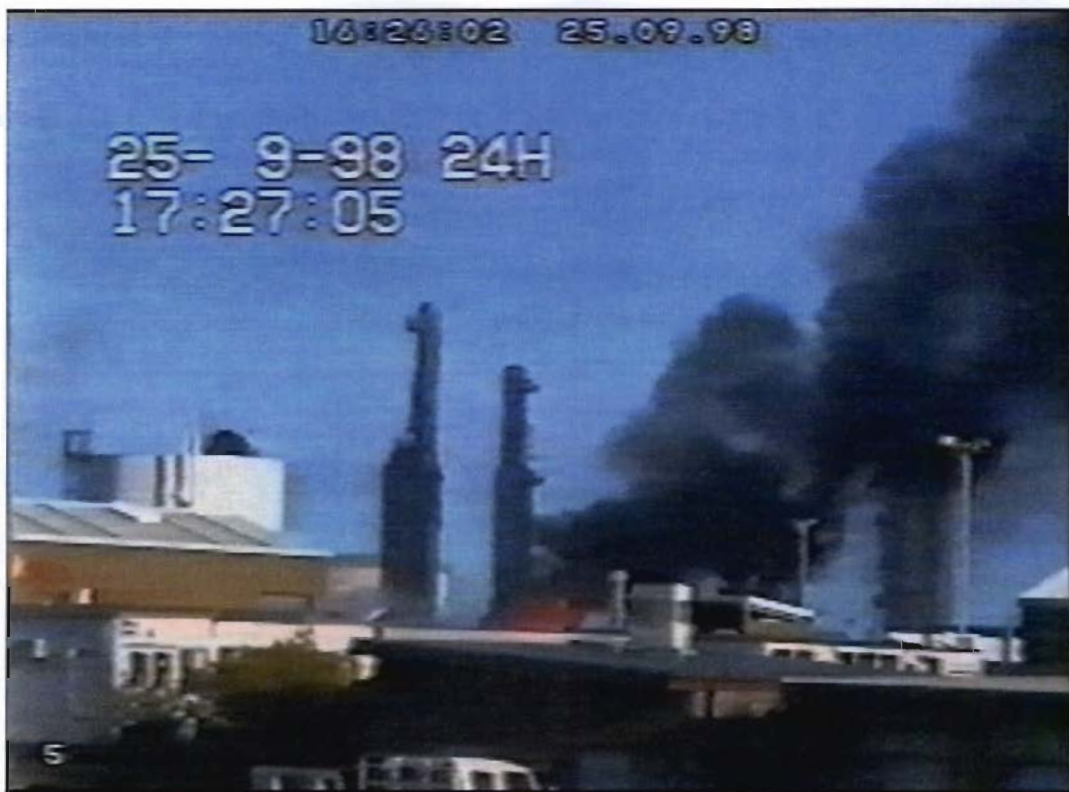
*Figure 7.13 The fire at 16:26:02*

7.48 At 4.27 pm there was a report to the Incident Control Centre that there were small fires around the LPG booster pumps and the product debutaniser. It was also reported that there were small fires on the flanges on the east side of the product debutaniser. The isolation of the absorbers cut fuel supplies to the debutaniser and the fires were extinguished. The security videos shows that at this time the top of the flames were just visible from the entrance gate, over the roof of the building in the foreground. The smoke had also lightened.

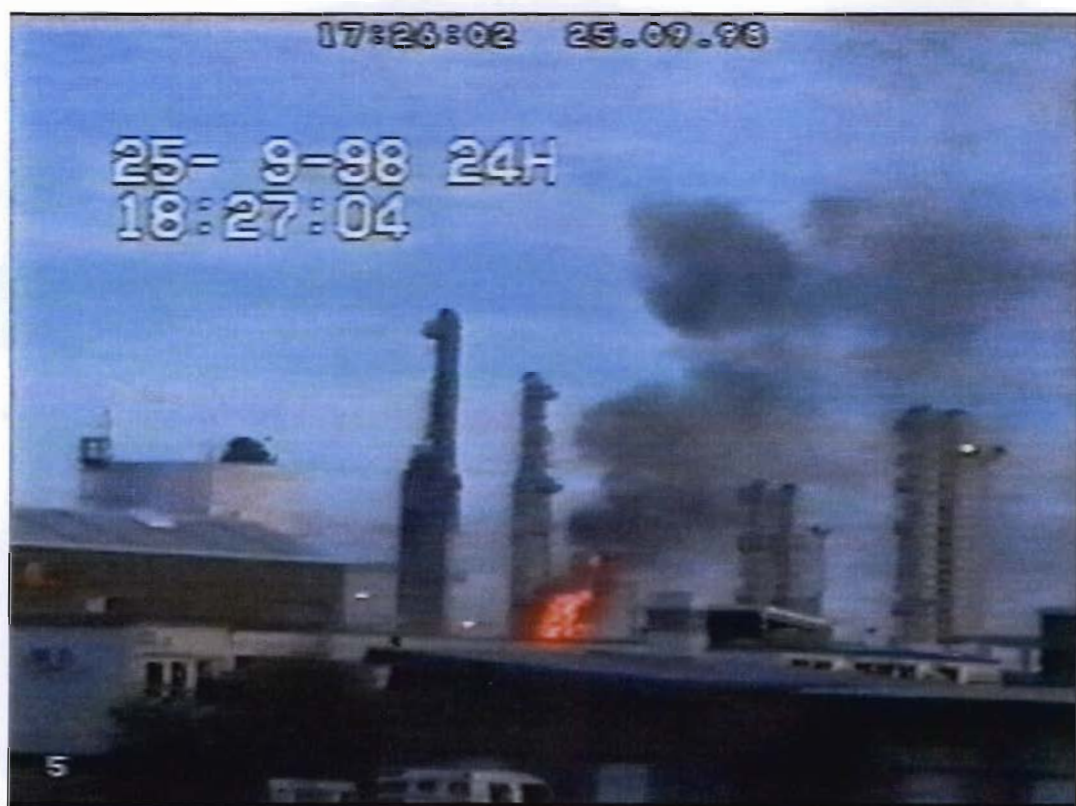
*Figure 7.14 The fire at 17:26:02*

- 7.53 By around 5.30 pm the flame height in the vicinity of the seat of the fire had diminished further. The flames were yellow-red in colour and approximately 10-15 metres in height.

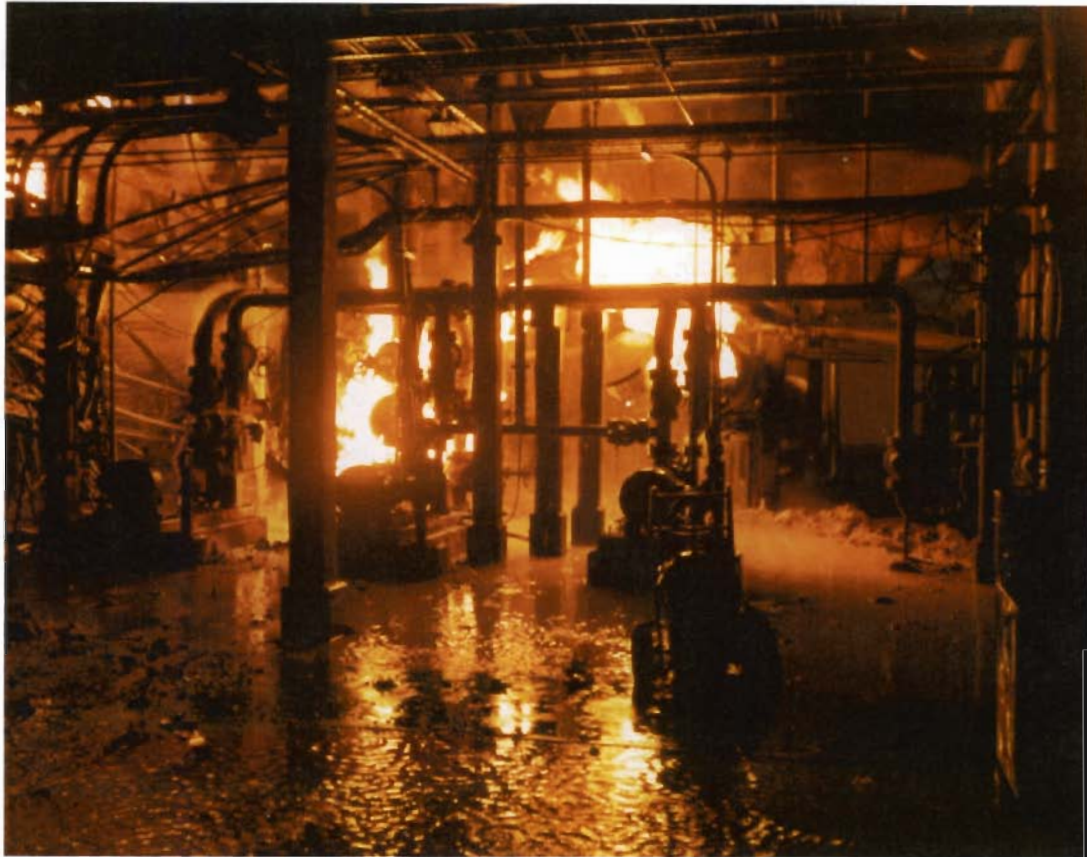
*Figure 7.15 The fire from behind the GP1201 pumps, at approximately 5.30 pm*

- 7.54 At this time members of the fire team were able to move in close to the fires that continued to emanate from the two exchangers GP905 and GP922. The picture depicted in Figure 7.15 was taken by one of the members of the team. The flames from GP905 depicted in the photograph, were approximately three meters in length and one meter wide. The flames from GP922 were fan shaped, emanating from various gaps between the end plate and the exchanger body.

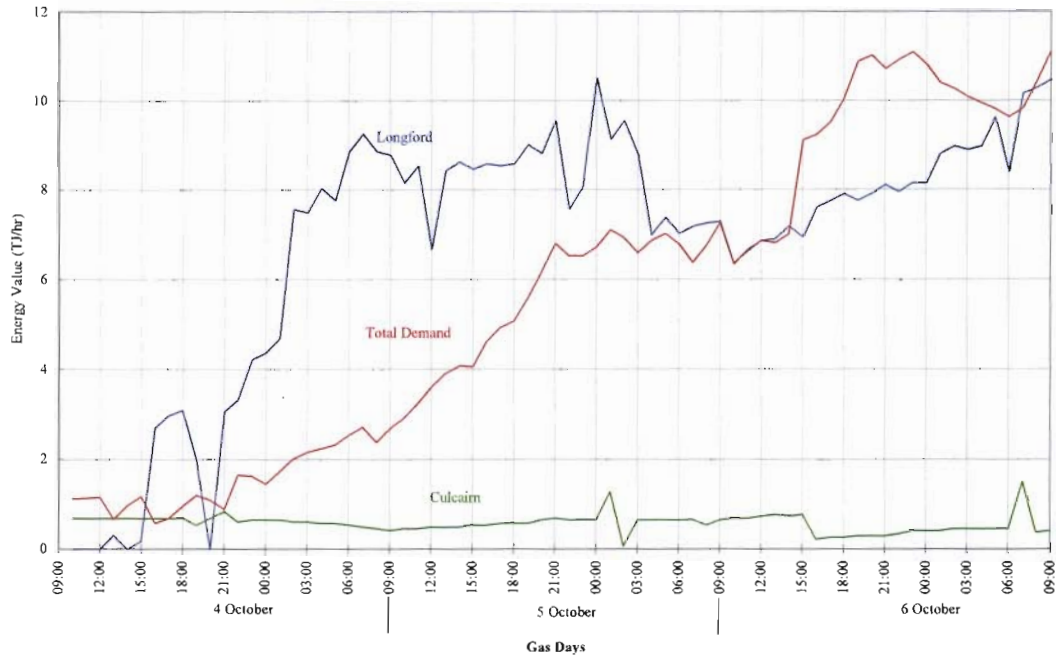
**Figure 9.1 Gas sales for 4 October to 6 October 1998**

- 9.31 By 2.00 pm on Sunday, 4 October, GP2 was ready to supply specification-quality sales gas. Gas sales commenced at around 2.45 pm. The Gascor sales gas chart for gas days 4 October to 6 October 1998 is shown in Figure 9.1. The gas day starts and finishes at 9.00 am, which is almost universal practice in the natural gas industry.

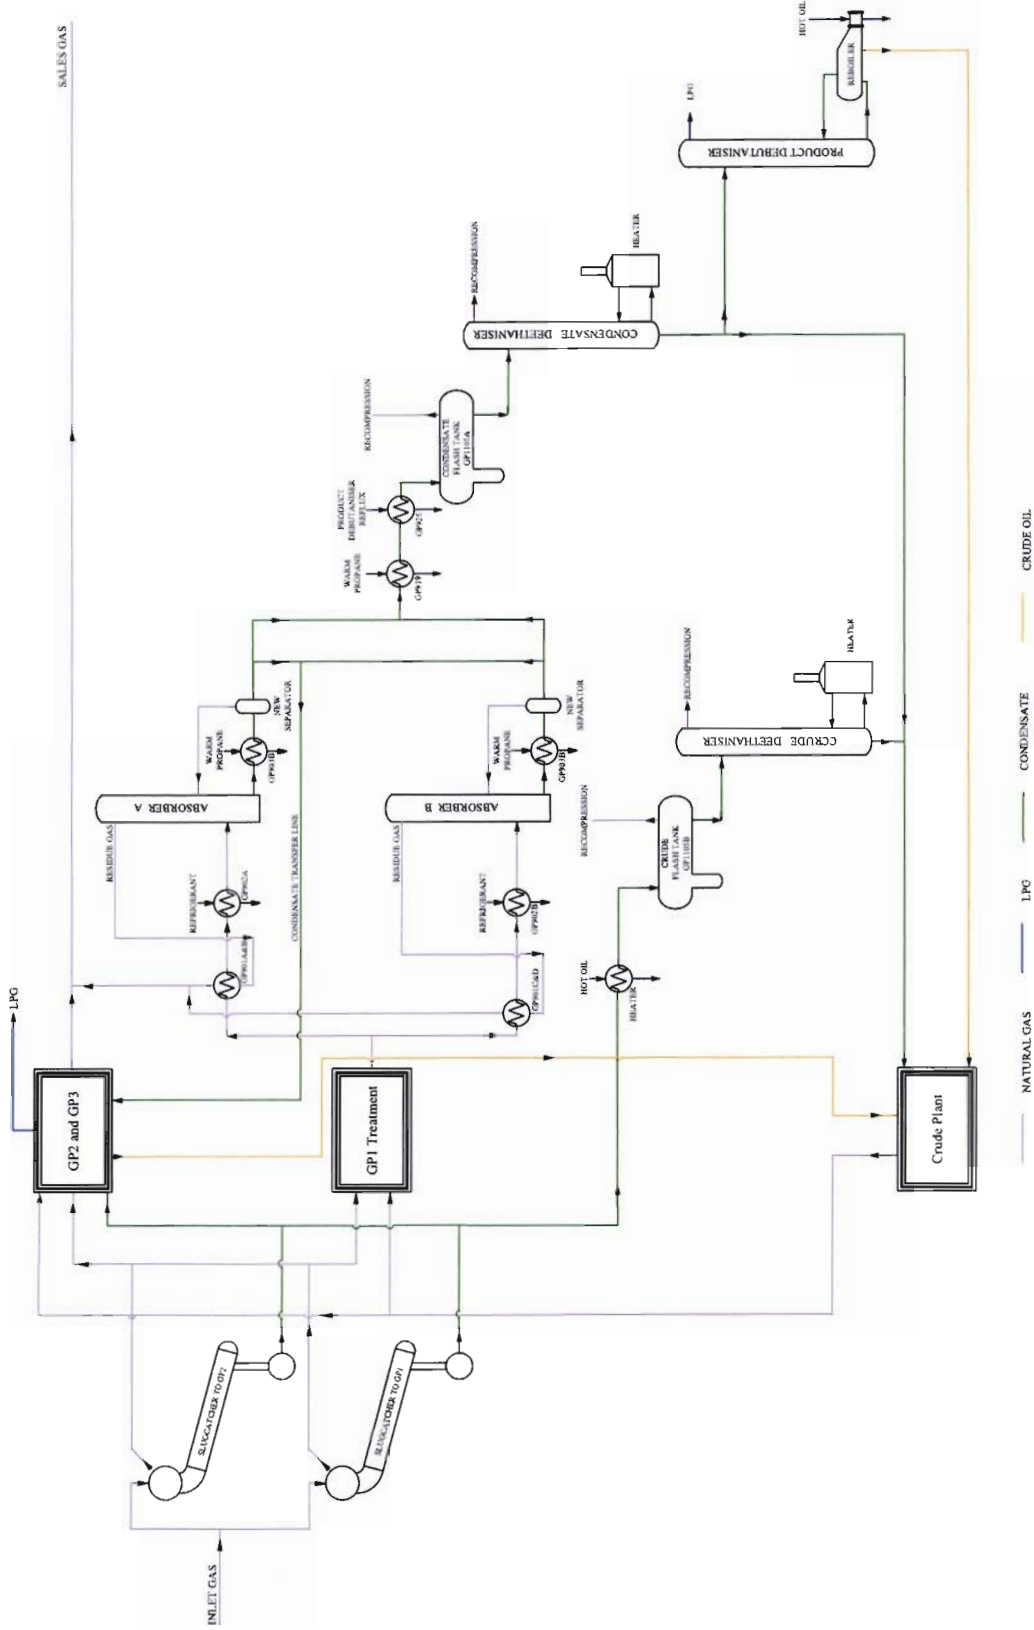
Figure 9.3 Modified GPI process after Phase 3

9.69 Figure 9.3 is a diagram of the modified process after completion of Phase 3. This process will produce sales quality gas that will flow from the top of the absorbers. The condensate leaving the bottom of the absorbers will be heated by GP903A and B to about -5°C. This mixture of vapour and liquid will flow to the new separators for removal of the vapour which will join the gas passing up through the absorber. The remaining condensate will be flashed to 3100 kPa through the absorber level control valves LY9A and B and then combined into one stream to be warmed by the two heat exchangers GP919 and GP925. After separation of vapour and liquid in the Condensate Flash Drum, GP1105A, the liquids will pass through the Condensate De-ethaniser Heater, GP921A, and enter the Condensate De-ethaniser, GP1106A. The overhead vapours from the Condensate Flash Drum and the De-ethaniser will be recompressed and returned to the inlet of GP1. The bottom product from the De-ethaniser will be fed to the Product Debutanisers in the CSP.

- 9.67 The existing processing system consisting of the Condensate Heater, GP919, the Condensate Flash Tank, GP1105A, the Condensate De-ethaniser Feed Heater, GP921A, and the Condensate De-ethaniser, GP1106A, will be supplemented by a number of additional items of equipment. A condensate separator downstream from each of the GP903A and B heaters will return the separated vapour to their respective absorbers. The conversion of the existing GP925 Rich Oil Exchanger to condensate warming service will provide additional heating downstream from GP919. The heating medium for GP919 will revert to warm propane, and the heating medium for GP925 will be reflux liquid from the CSP Product Debutaniser which was used on GP919 before the September accident.

- 9.68 Two new Product Debutaniser reflux pumps dedicated to supplying GP925 are to be added, together with two new Condensate De-ethaniser pumps dedicated to a new warm-up recycle line connected to the condensate line from the absorbers to the Condensate Flash Tank, GP1105A. When in operation, this equipment will enable the chilling of treated gas to -32°C prior to separation of condensate liquids in the absorbers.

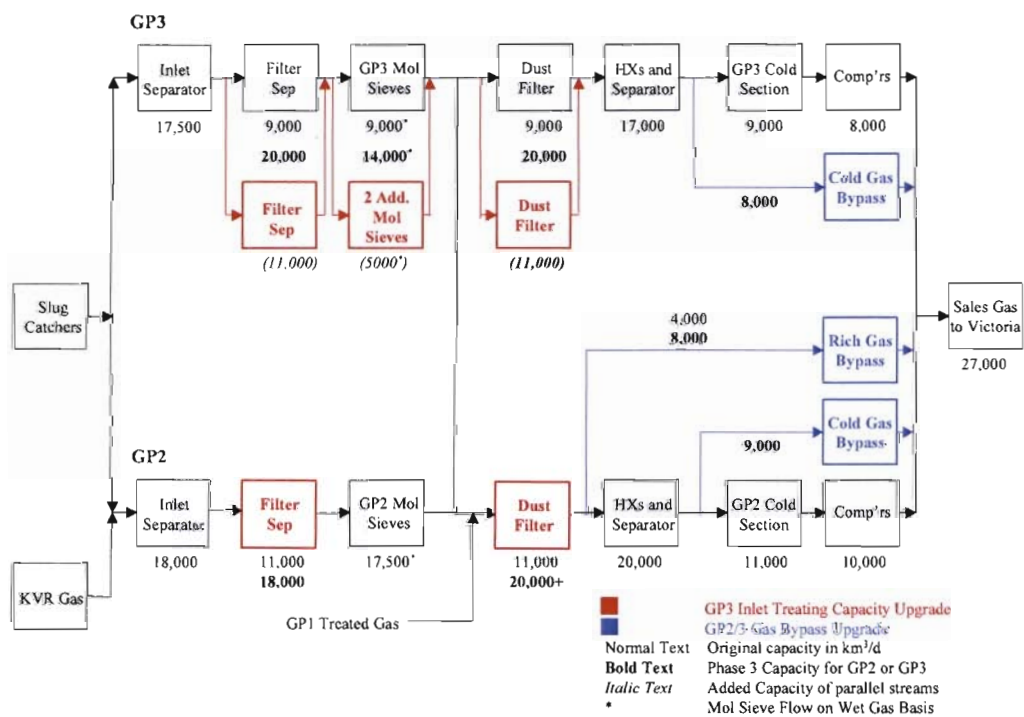
Figure 9.4 De-bottlenecking block diagram

9.88 This de-bottlenecking of capacity is illustrated in Figure 9.4 which shows the additional facilities required and the expected output in thousands of cubic metres per day (km<sup>3</sup>/d). GP2 is being fitted with a larger filter separator, a larger dust filter and a larger rich gas bypass together with a new cold gas bypass. GP3 is receiving the filter separator and dust separator removed from GP2 which will be installed in parallel with the existing units. Two additional molecular sieves and a new cold gas bypass are being added.

- 9.89 The rich gas bypass in GP2 feeds gas from the molecular sieves into the sales gas stream. As this gas has not been cooled, it will still contain its heavy components and therefore will have a high heating value and Wobbe Index number. This restricts the amount that can be added to the sales gas without exceeding the sales gas specification.

9.87 As the sales gas produced by GP2 and GP3 is well within the quality specification limits, Esso has decided to install additional treating equipment and bypass lines within those two plants to allow the use of treated or partly processed gas to supplement sales gas output during times of operating difficulty in the gas plant.
